KOOTENAI DEVELOPMENT IMPOUNDMENT DAM
OCTOBER 2011 ROUTINE OWNERS INSPECTION

Prepared for: The Remedium Group

Prepared by: Kurt Hafferman, P.E.

Inspection Date: November 01st, 2011
Report Date: January 12th, 2012

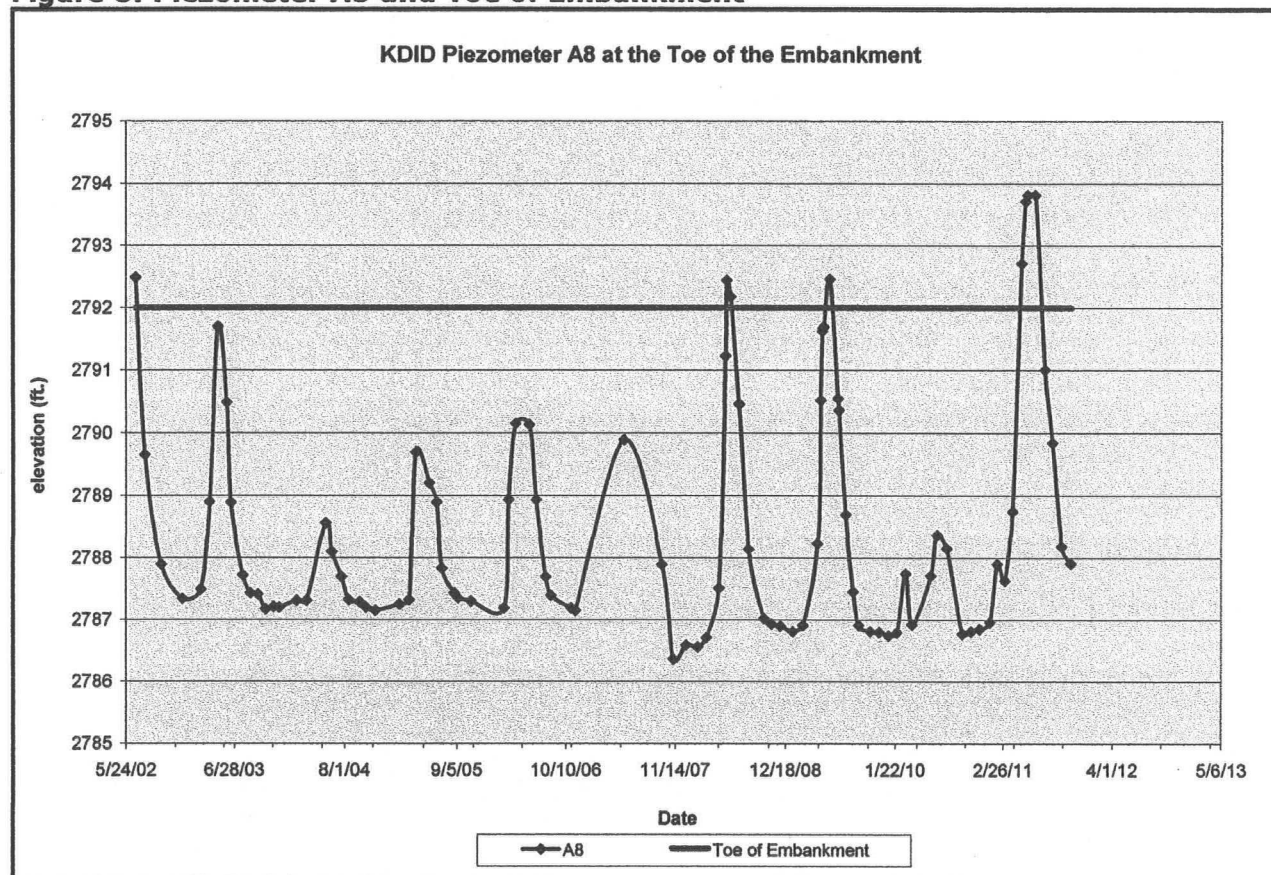
Figure 8: Piezometer A8 and Toe of Embankment

The graph above continues to show that piezometer A8 is dropping slower than the other piezometers on the site and shows the phreatic water surface at the toe of the dam is still higher than has been previously recorded. Water levels this year at A8 have risen higher and fallen slower than past years and indicate the volume of groundwater still present and moving below the dam. Figure 8 below shows piezometer A8 with the toe of the dam.

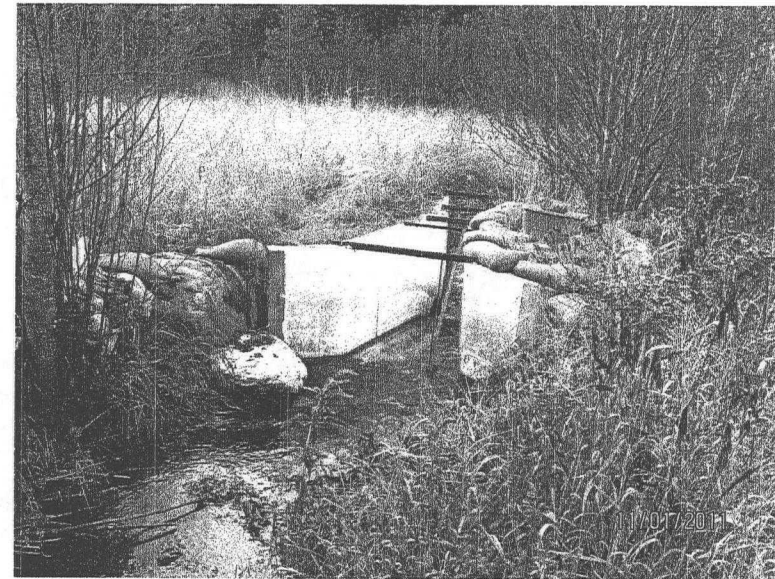
2. The LRC-06 flume was checked at the end of the inspection. The flume was clean and clear and a gauge reading was taken and recorded.
3. Carney Creek and Lower Rainy Creek Flows: Flumes CC-02 and LRC-02 respectively were read. Flumes contained trace amounts of sediment, they were cleaned and the stream flows were noted as clear. The flume gauge readings were taken and recorded and are as follows;

LRC-02 Flume

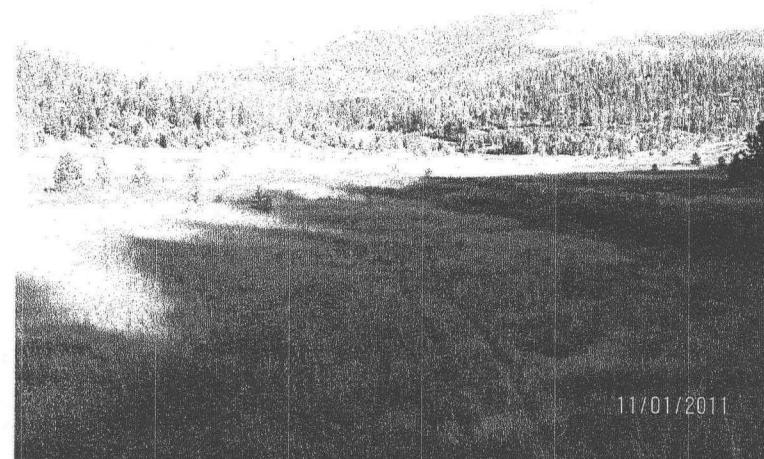
7. No bulges, erosion or other anomalies and/or changes were noted to the embankment from the upstream face to the toe.
8. The spillway was not running and the entrance channel was dry.

Spillway Entrance Channel

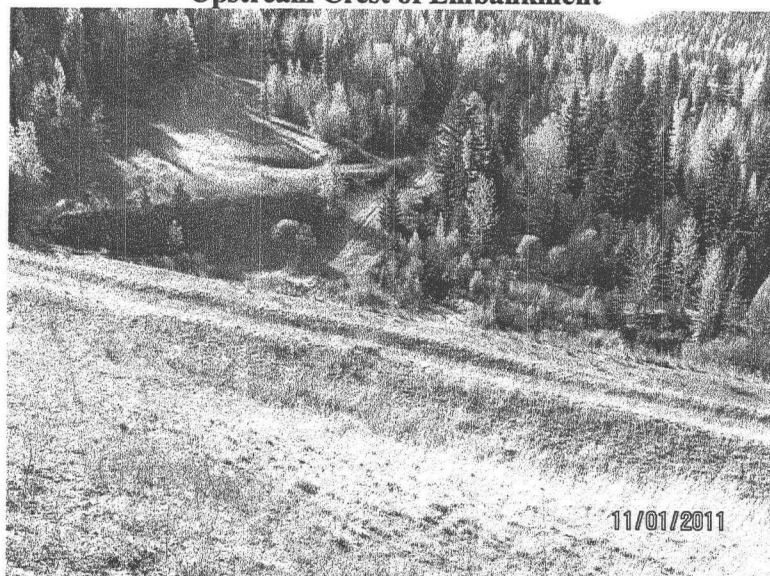
Downstream Face of Embankment

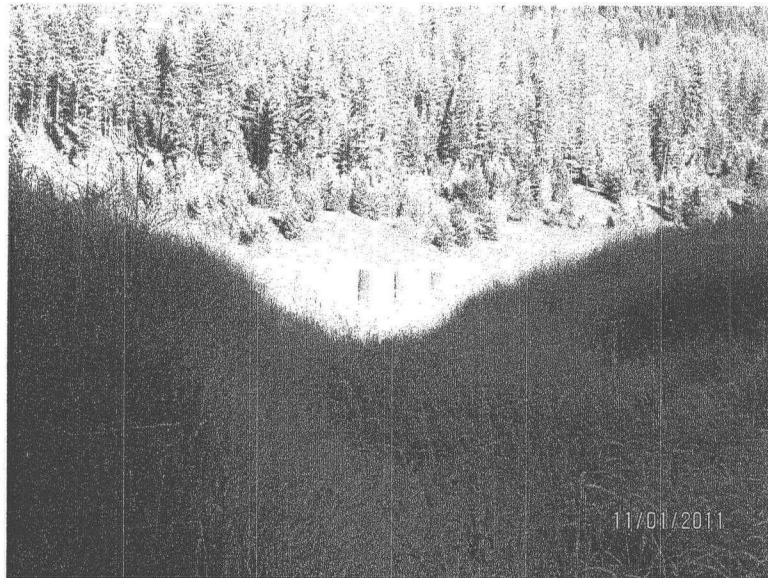
No changes in the spillway have been noted in the past month. Photos of the centerline cracks were taken during this inspection and show no significant changes since spring runoff occurred this spring. There is some debris accumulation occurring but nothing that will hinder flows if they were to occur.

Trash Rack

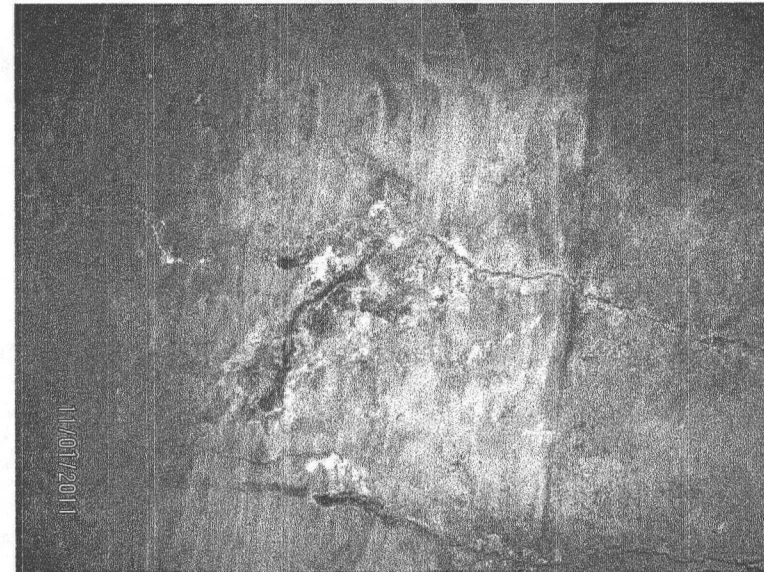
Cracks in Box Culvert

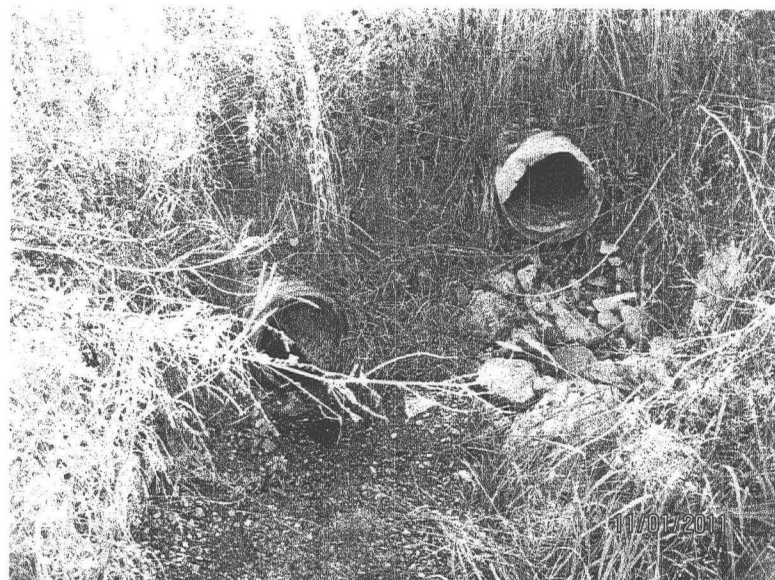
Flows in drain 1 have ceased for the season. Drain 2 is still running with a slight decline in flows over last month. We still continue to see the black sediment globs that have been noted at the outlet of the drain.

Drains 1 and 2

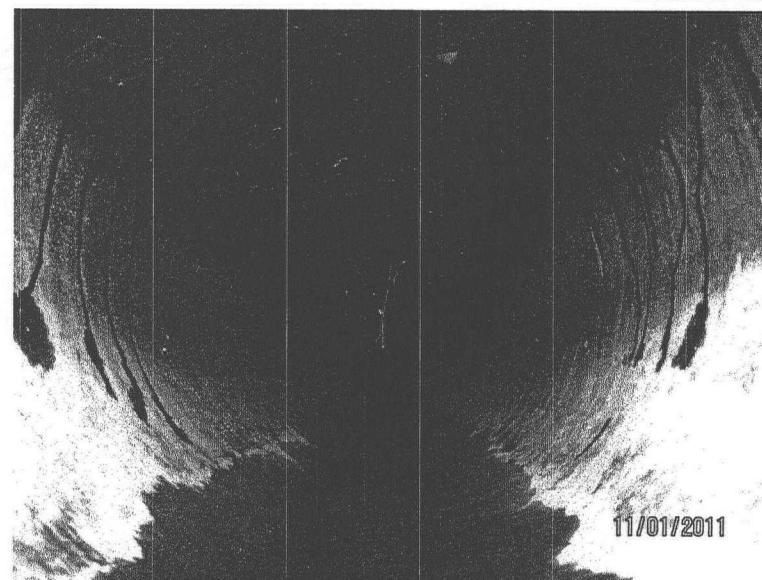
Inside Drain 2

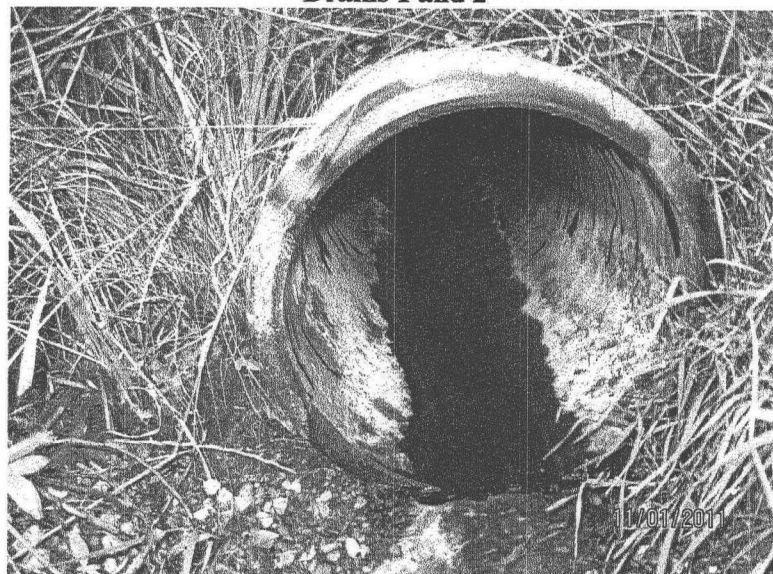
Drain 2

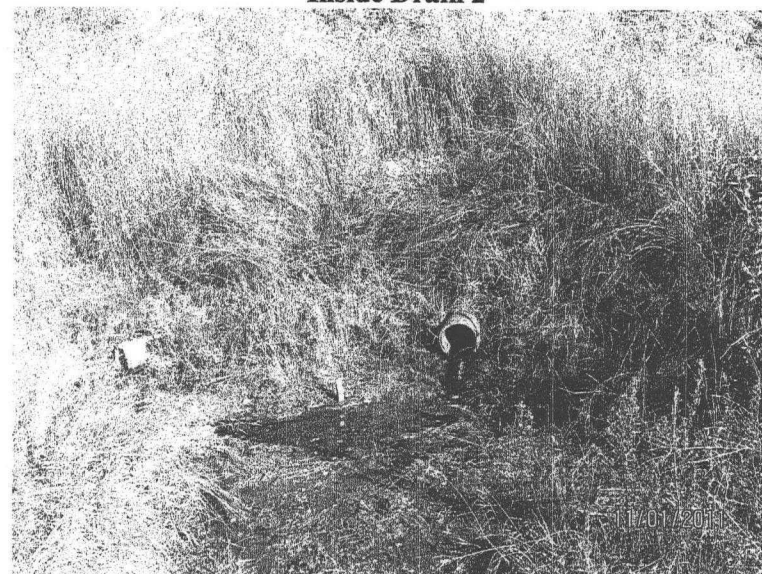
All flows were noted as clear and steady with no visible transport of sediment in the drain water. Small root wads continue to be noted in a few of the drains on the project but do not appear to pose an immediate threat to drain flows. If they do not wash out before spring flows, an effort should be made to remove them.

Drain 3 and 4
